Palatine Public Library District Main Library 2022 Capital Maintenance Plan

As Approved
Updated with Allowances for Water Infiltration
May 31, 2022

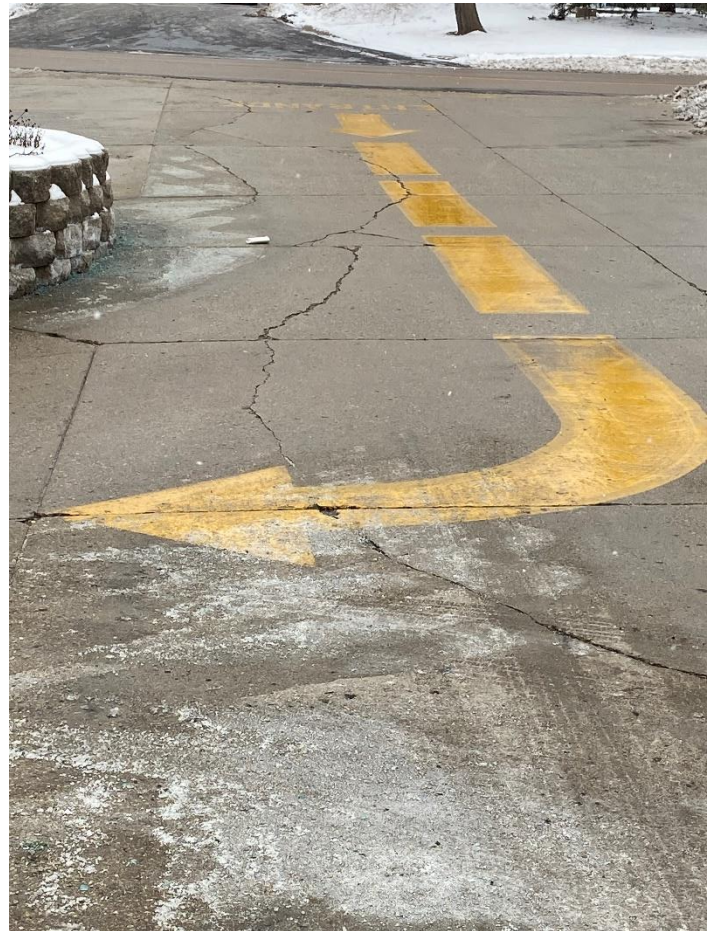
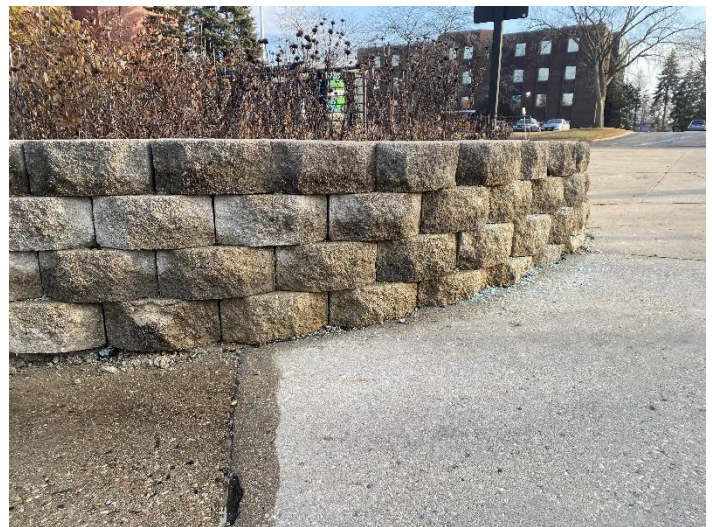
The retaining wall that forms the area well serving the lower level and supporting the building entry is showing signs of deterioration. Repairs have been forestalled by removing vines and allowing the block to dry. The vegetation is beginning to return and should be cropped back again. Repairs to the top layer of the major retaining walls are included in the study. More extensive deterioration of the retaining wall at the mechanical well are the result of moisture and salt. Repairs are anticipated in the study. These should be coordinated with the concrete paving repairs and any measures needed to address water entering the building through an electrical service conduit.

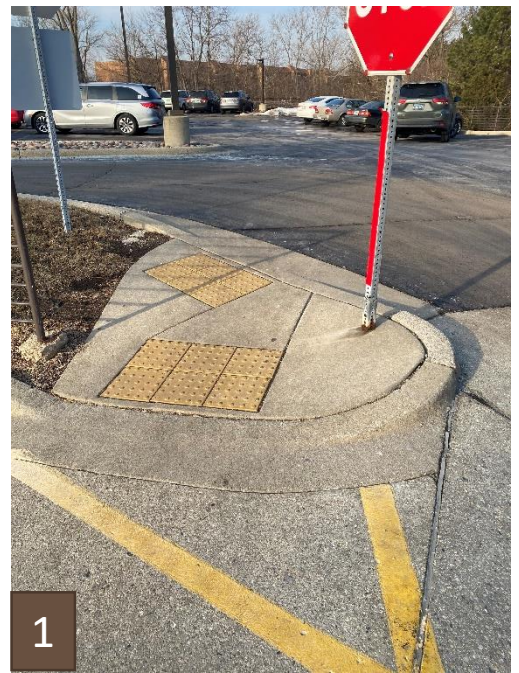
1

Confirm ramp slope and sidewalk slope that is behind the ramp. If the ADA tile is sloped greater than 5%, then it is a RAMP and there will need to be a level landing behind the ramp. Regardless, the slope of the sidewalk that is running perpendicular to the ramp should be no greater than 2% side slope. See photos 3 and 4. We are not sure why these ramps are even there because they don't connect to a sidewalk crossing on the opposite side of the street. Could they be left over from an older design?
