Palatine Public Library District Main Library 2022 Capital Maintenance Plan

As Approved
Updated with Allowances for Water Infiltration
May 31, 2022

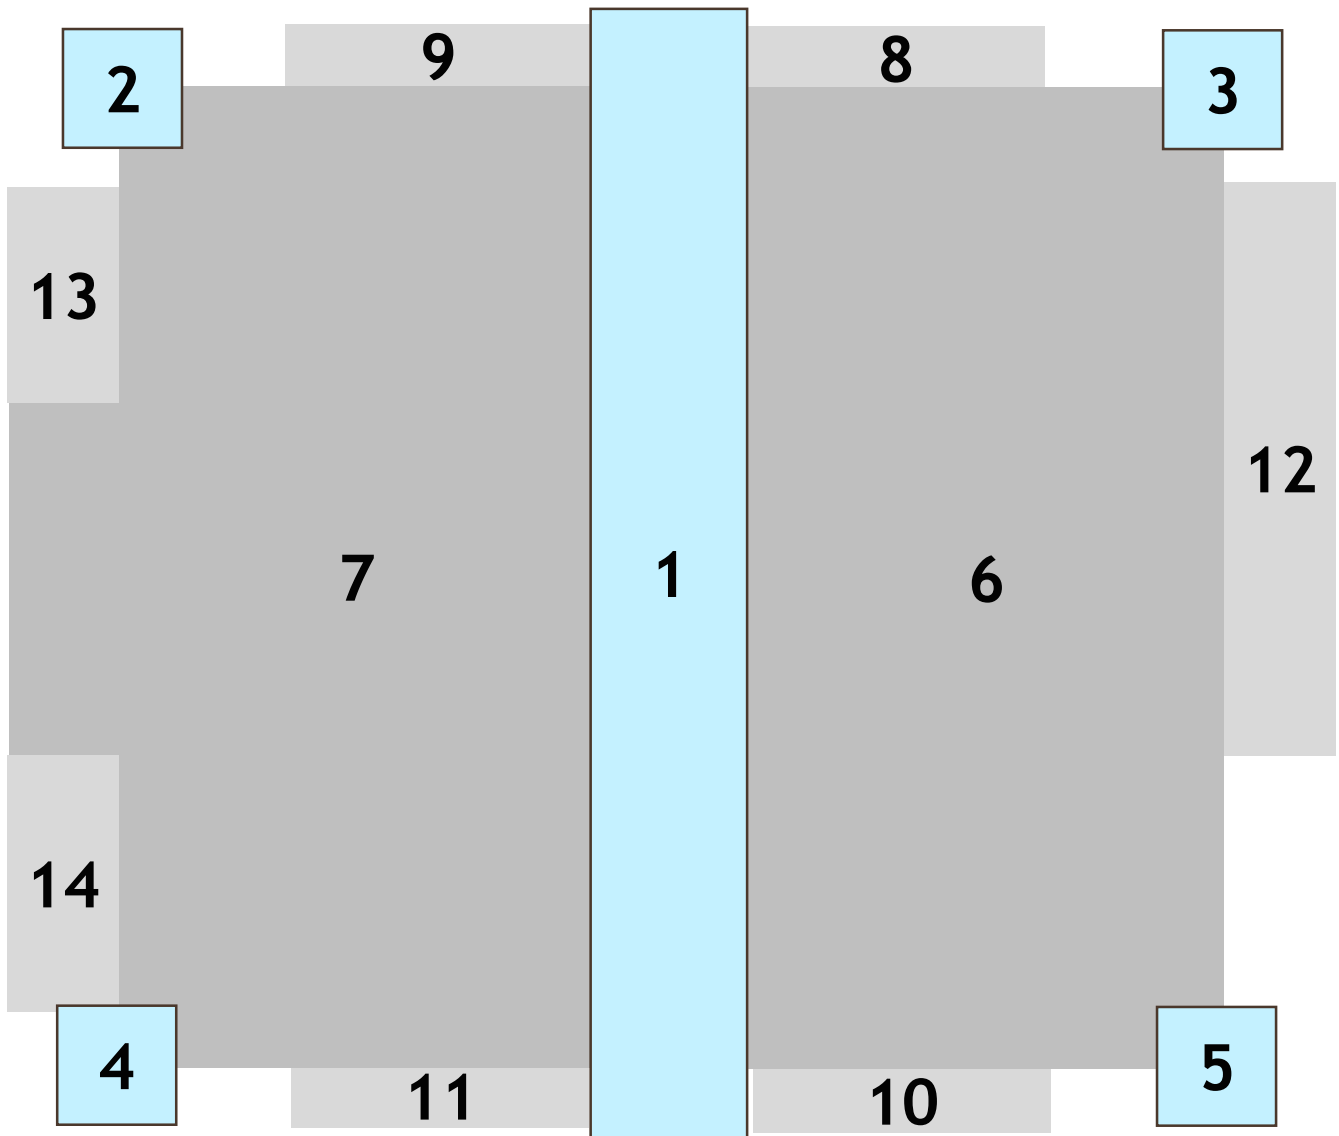
Roof Zone Diagram

The present value estimate for the roof replacements is \$1,930,000. Escalated costs at the anticipated replacement years total \$3,120,000.
